BY SPFA'S CONSULTANT COMMITTEE, MASON KNOWLES, ROGER MORRISON, PHIL ROBARGE, JOHN HATFIELD, ROB SMITH

What is meant by a "secure" substrate?

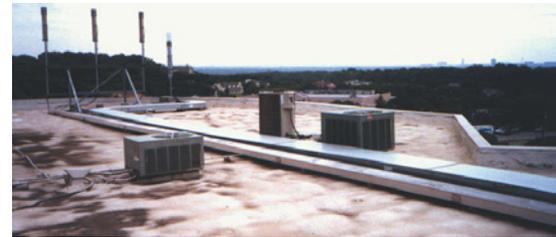
Case Study 1: SPF shrinkage caused roofs to structurally fail at edges and parapets. In this case, the SPF applicator applied unusually thick SPF (as much as 5-6 inches) onto several existing BURs. Contractive forces were sufficient to pull parapet walls in toward the field of the roof, cracking masonry joints and loosening brickwork; or lift up roof edges, exposing the interior to water intrusion. Investigation revealed the following:

- The underlying roof membranes (i.e., the SPF substrate) were securely attached to the roof edges or parapets but were poorly attached to the roof deck; and
- The contractive forces (shrinkage) of the SPF was proportional to the volume or mass of SPF adhered to the loose membranes (i.e., the thicker the foam, the greater the force).

Damage could have been prevented or mitigated by:

- Applying less thickness of SPF at the roof perimeters.
- Fastening the existing roof membrane in perimeter areas.
- Removing the existing roof in perimeter areas and applying SPF directly to the roof deck.

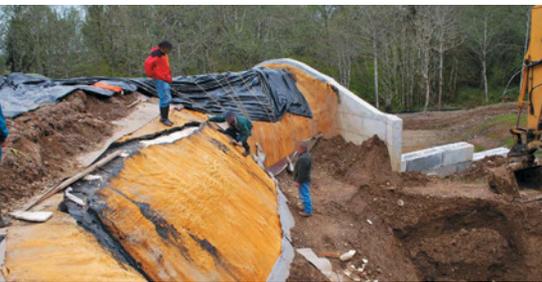
Case Study 3: SPF insulation was applied to a waterproofing system that had been applied to a structural concrete, subterranean residence; shrinkage of the SPF caused the waterproofing

system to fail cohesively resulting in a crack in the insulation and waterproofing (and leakage). Investigation revealed that the SPF was well adhered to the waterproofing system but the waterproofing compound itself (a spray-applied, water-based, modified asphalt emulsion) was incapable of transferring the shrinkage forces into the structural concrete.

Failure could have been avoided by spraying the SPF directly to the concrete structure and applying the waterproofing to the exterior surface of the foam. ○
