FoamCoat Roofing & Coatings: Burlington Composting Facility

Type of Job: **Apply foam and coating to all interior metal**

2009 SPFA Industry Excellence Awards

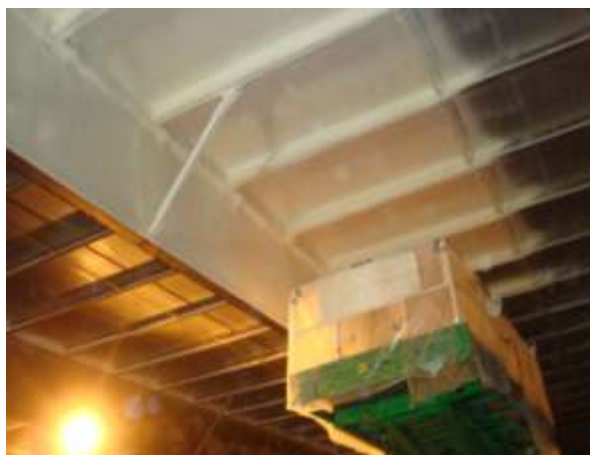
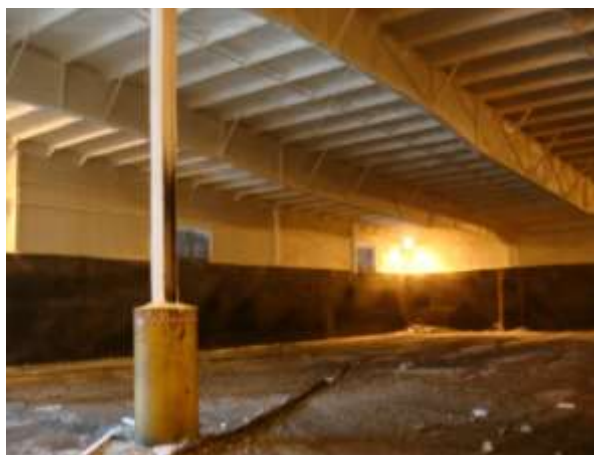
Project Description: The average life of a compost facility is fairly short. Storing compost at a high-enough temperature to have it decompose properly (target at roughly 120 degrees, but at a minimum 90 degrees) creates extremely humid conditions and gases. The facility is 100% humidity 100% of the time. Burlingtons facility was at the end of its life cycle. However, instead of destroying the structure and starting over, the facilities management group for the facility contracted with FoamCoats corrosion control system to salvage the facility. Some steel perlins and Z-beams were damaged too badly and were replaced. The roof, ceilings, metal portions of the walls, and all structural steel were then covered with foam and corrosion resistant Stayflex coating. The condition of the roof, ceiling and walls was not good and required extensive prep work to get the surfaces ready for the various applications. The facility was needed so the management group wanted the job done as quickly as possible. With just over 300,000 square feet to complete, FoamCoat used four spray crews; two operating at a time, two shifts per day, six days a week. Due to space constraints, many spots required a considerable amount of hand work to ensure the desired coverage of foam and coating.

Benefits of using Foam: The job was completed in a timely fashion. All metal is now protected and will now become a minimal maintenance item, instead of the major headache it had become. It is attractive and has very good reflectivity which will be helpful in a dimly-lit environment. The steel is completely encased with foam and coating and now has an indefinite life expectancy, with testing of this system showing no measurable deterioration after twenty years. It can be hosed down without damaging the coating to keep the gains achieved in improved reflectivity and appearance.
