Roof repair on the 8th Wonder of the World "Grand Coulee Dam"

2011 SPFA Industry Excellence Awards

Category: Roof Foam > 40K sq.ft.

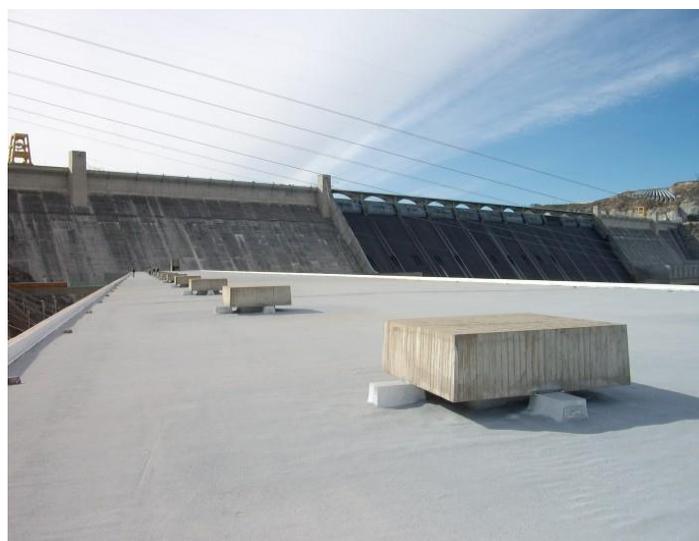
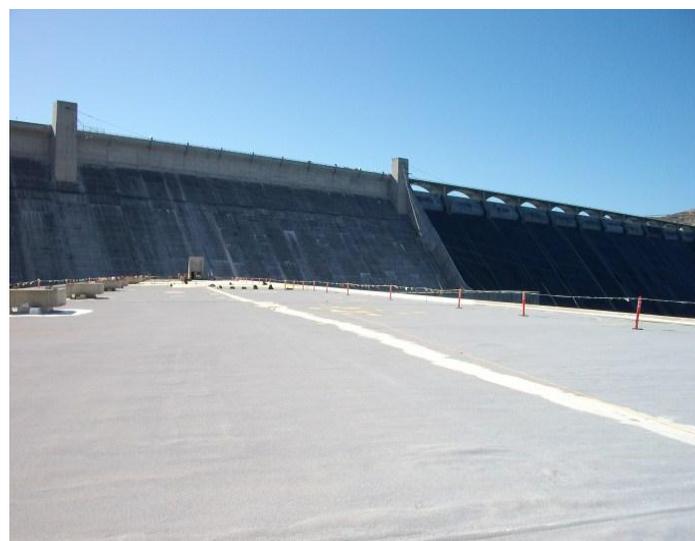
Project Description: Remove and replace 120,000 square feet of sprayed polyurethane foam and its silicone coating. Using scarifiers remove the contracted 1 1/2" of foam from all nine floating roof panels, each panel is 120 x 112. During the removal of the 1 1/2" of foam it was discovered that 3 roof panels and a part of a 4th were water logged and up to 12" of foam was removed. Products used are United Coating, uniseal primer, BASF's elastospray, 3lb foam was applied by Silver Eagle Robtic Sprayer to achieve 12" of sprayed foam. United Coatings, elastuff 101 base coat to approximately 15 mils in one pass, sprayed United Coatings, Elastuff 102 top coat to approximately 45 mils, DFT in three passes, broadcast 3-M#11 granules into last coat. Up to 32 people worked on this job; over 51% were Colville Indian Tribe members as half of the dam sits on the Colville Nation land. Our work was on that side of the dam. During scarifing and clean up extra caution had to be taken that no debris went over the 1' parafit wall and into the transformers, as foreign material can cause damage and a shut down. The roof itself had to remain water tight as water getting into the generators would result in a shut down also extreme care had to be taken and monitored while the work was done.

Benefits of using Foam: The original roof served for 30 years, why change success. Weight consideration as each of nine roof panels are floating panels. Cost repair is minimal rather than complete removal and re roof. Newly repaired roof is warranted for 20 years.
