Fairview Swiss Cheese Tanks

Type of Job: **Tank Insulation, Acrylic Paint**

2011 SPFA Industry Excellence Awards

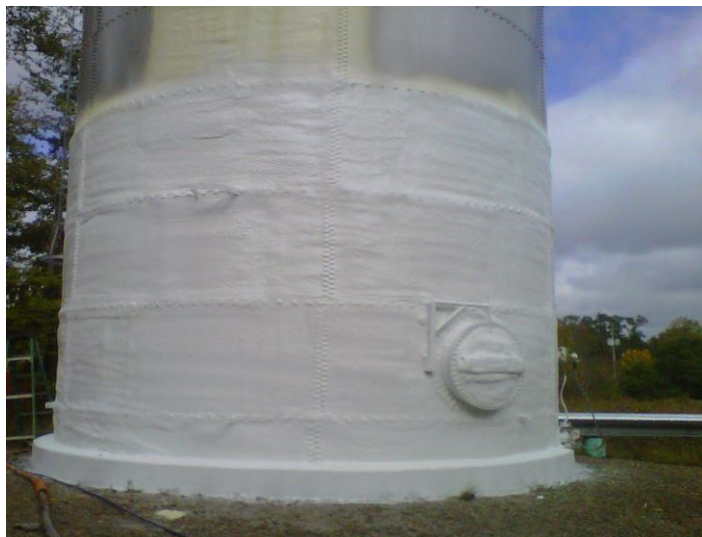
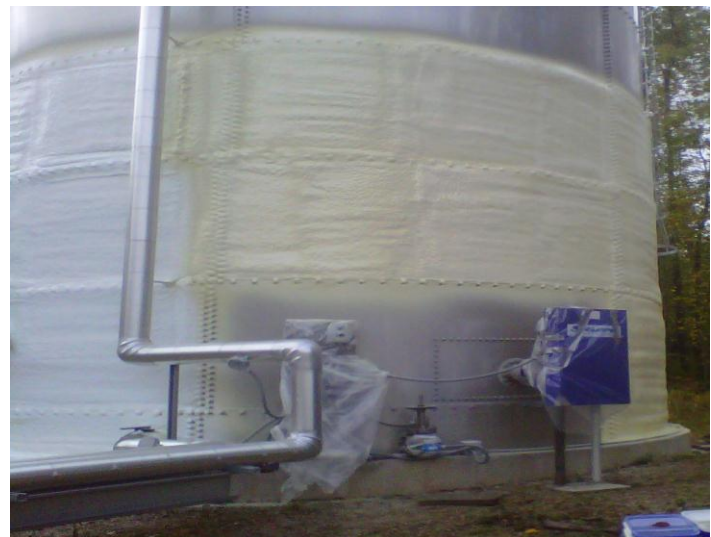
Project Description: The outdoor storage tanks were sprayed with 2 inches of closed cell spray foam to achieve a moisture and thermal seal. The foam was then coated with an elastomeric acrylic coating, Thermo Flex 1000. The unique qualities of the project consist of spraying a consistent 2 inch layer of foam conforming to the perimeter of the tanks. The weather was an issue dealing with Pennsylvania's Fall including high winds and rainy days. The benefits of using the acrylic coating include; a waterproof membrane, preventing substrate degrading UV light, resists staining and dirt pick-up, reduces risks of wind damage and thermal shock. The day after completion, the owner immediately recognized the impact of the foam and was very satisfied.

Benefits of using Foam: The tanks sprayed are intended to process cheese with certain constant temperatures over a period of time. The metal tanks would consistently fight outside temperature changes to maintain the desired temperature inside the tanks. Insulating the tanks with closed cell spray foam will control the desired temperatures inside the tanks to process the cheese more efficiently. Spray foam is the best way to insulate tanks and vessels because of the capabilities to conform to any surface sprayed.
