# Energy Shield, Inc.:

## USPS-Saginaw, Michigan

Type of Job: **Re-roofing**

**2009 SPFA Industry Excellence Awards**

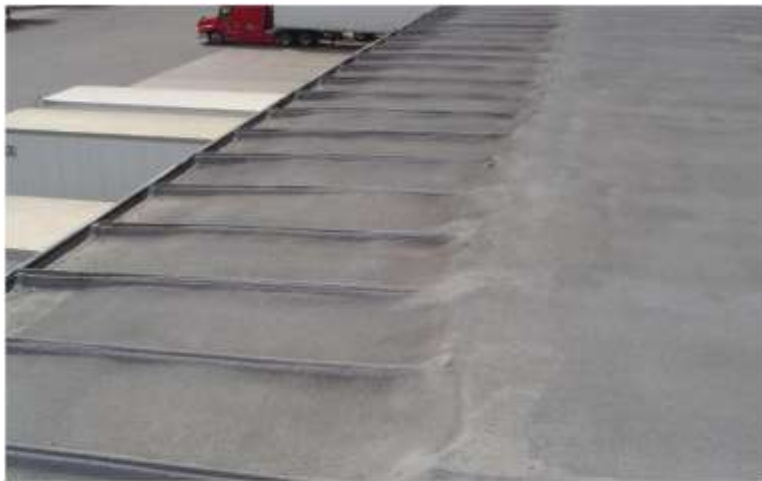
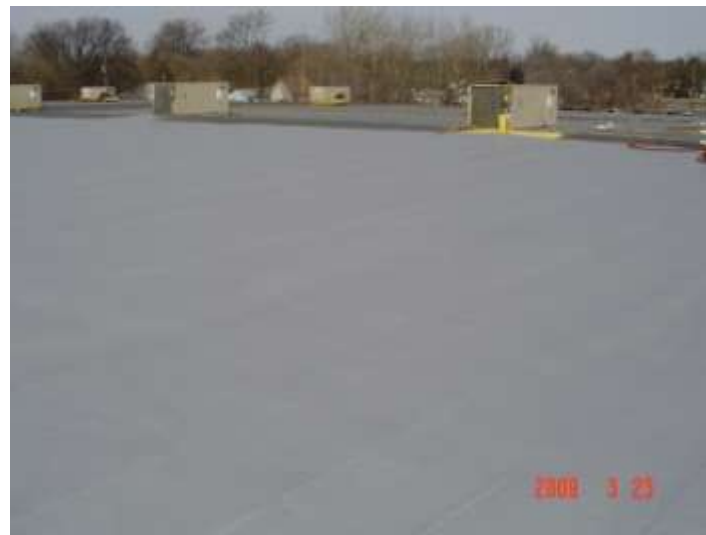
**Project Description:** Saginaw Michigan, US Postal Service mail processing center. 50,000 square foot, standing seam metal roof that had 18 roof top mounted HVAC units that required frequent maintenance. There were numerous leaks at the overlapping seams and around units. The system used consisted of:

1. adhering a 2½ iso-board (pre-beveled) onto the metal roof between the standing seams using Firestone Iso 95+ polyiso foam adhesive.
2. Over the board, BaySystems primer was installed followed by a 2 layer of BaySystems 3.0lb density foam forming a continuous near-flat roofing assembly over the entire roof. Standing seams were completely buried beneath the foam.
3. Over the foam, the BaySystems silicone rubber membrane with granular surfacing was then installed to meet 20-year performance criteria

**Benefits of using Foam:** Stop the numerous roof leaks at seams and around HVAC units. Alter the roof surface to facilitate access to HVAC equipment for frequent repairs. They wanted the roof to be relatively flat/smooth to facilitate walking and rolling hand-carts. The finished roof system now offers a uniform roof surface for walking and movement of small rubber tired carts. With granular surfacing, it is slip-resistant and able to handle most random foot traffic. Roof pads were installed around the scuttle hatch and along side each HVAC unit at the access panels.
